**Flood Control Project Maintenance
Levee Inspections
LMA District Cover Sheet
Spring 2010 Levee Inspection Results**

Reclamation District No. 0003 Grand Island

Levee Inspection Report By Mile - Spring 2010

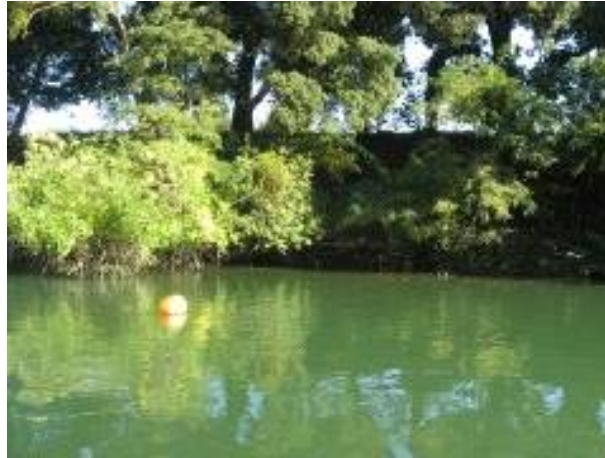
Levee Mile Report Line	3
Start Levee Mile	0.18
End Levee Mile	0.25
Location	Water Side
Category	Supplemental
Item	USACE Erosion Survey
2009: 5 ft berm, 1.5:1 slope, tree hazards, holes, and slumping, clays and silts, 4.76 ft/s [2009 SiteID:STM_26-0_L]	
USACE2009_STM_26-0_L_2009_09_18-D4P89_small.JPG

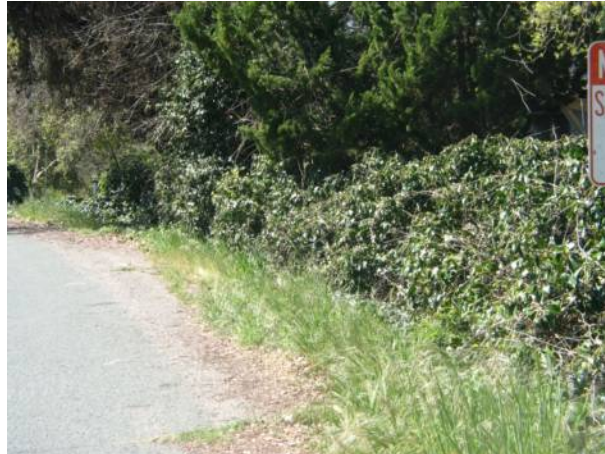
Levee Mile Report Line	4
Start Levee Mile	0.22
End Levee Mile	0.33
Location	Water Side
Category	Earthen Levee
Item	Encroachments
Dense landscaping on waterside from LM 0.22 to 0.28	
richard_s_20100505_013.jpg

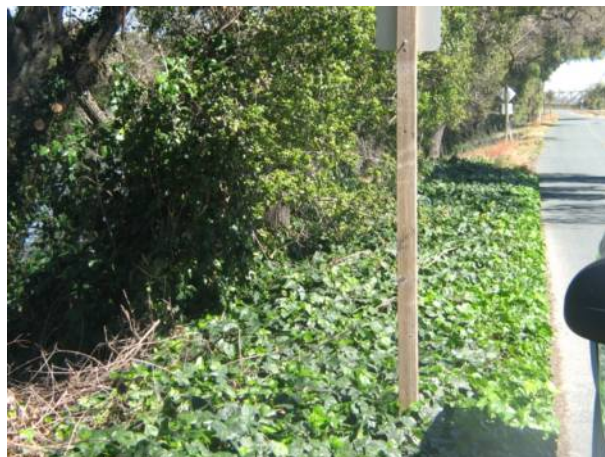
Levee Mile Report Line	4
Start Levee Mile	0.22
End Levee Mile	0.33
Location	Water Side
Category	Earthen Levee
Item	Encroachments
Looking upstream at dense landscaping on waterside slope from LM 0.22 to 0.28	
richard_s_20100505_014.jpg

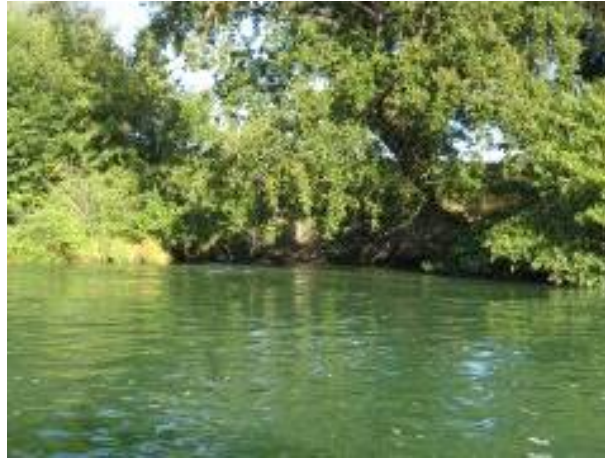
Levee Mile Report Line	7
Start Levee Mile	0.92
End Levee Mile	0.97
Location	Water Side
Category	Supplemental
Item	USACE Erosion Survey
2009: 5 ft berm, 1.5:1 slope, tree hazards and holes, clays and silts, 4.48 ft/s [2009 SiteID:STM_25-0_L]	
USACE2009_STM_25-0_L_2009_09_18-D4P91_small.JPG

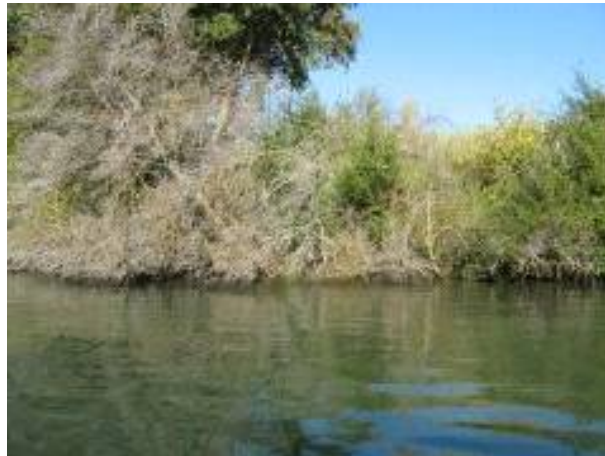
Levee Mile Report Line	8
Start Levee Mile	1.04
End Levee Mile	1.08
Location	Water Side
Category	Supplemental
Item	USACE Erosion Survey
2009: no berm, 1.5:1 slope, tree hazards and holes, clays and silts, 4.9 ft/s [2009 SiteID:STM_24-8_L]	
USACE2009_STM_24-8_L_2009_09_18-D4P93_small.JPG

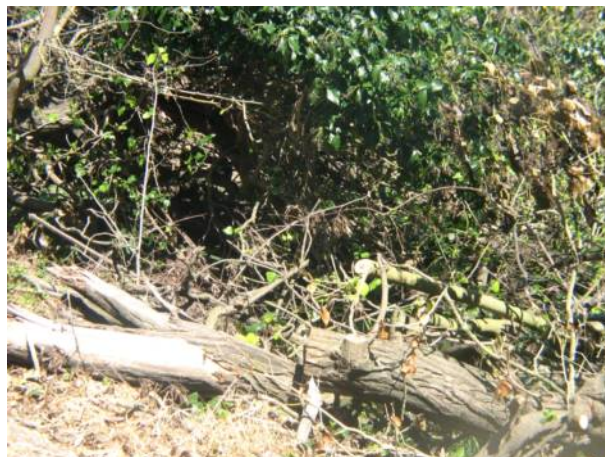
Levee Mile Report Line	9
Start Levee Mile	1.08
End Levee Mile	1.09
Location	Land Side
Category	Earthen Levee
Item	Encroachments
Down tree limbs on landside slope from LM 1.08 to 1.09	
richard_s_20100505_015.jpg

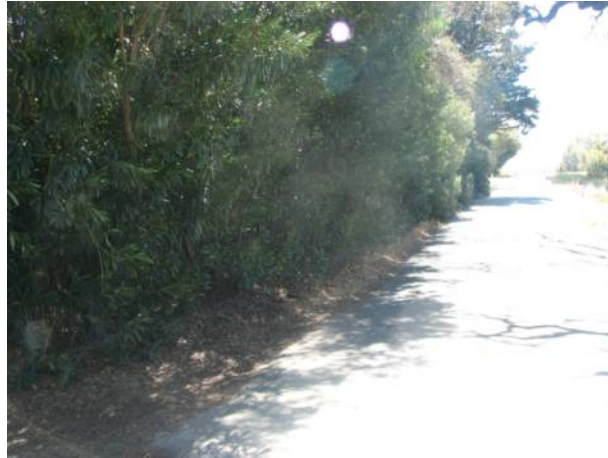
Levee Mile Report Line	10
Start Levee Mile	1.21
End Levee Mile	1.27
Location	Land Side
Category	Earthen Levee
Item	Encroachments

Landscaping on landside slope block view of levee from LM 1.21 to 1.27

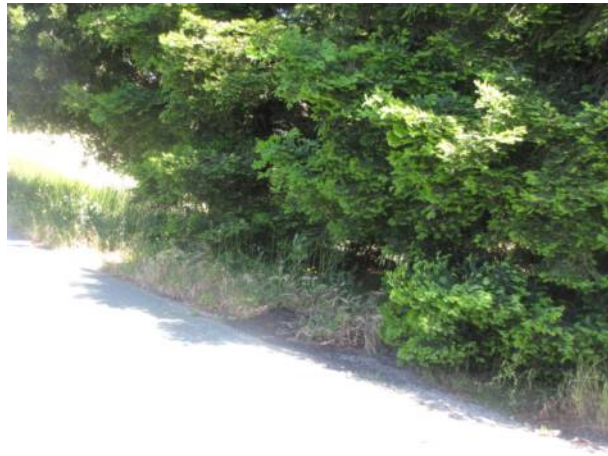
Levee Mile Report Line	12
Start Levee Mile	1.60
End Levee Mile	1.60
Location	Land Side
Category	Earthen Levee
Item	Trim / Thin Trees

Looking southeast at dense trees on landside shoulder and slope.

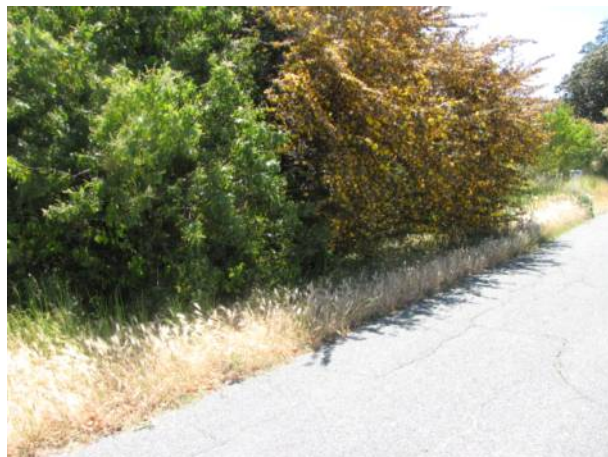
Levee Mile Report Line	13
Start Levee Mile	1.61
End Levee Mile	1.61
Location	Land Side
Category	Earthen Levee
Item	Trim / Thin Trees

Looking northeast at dense trees on landside slope.

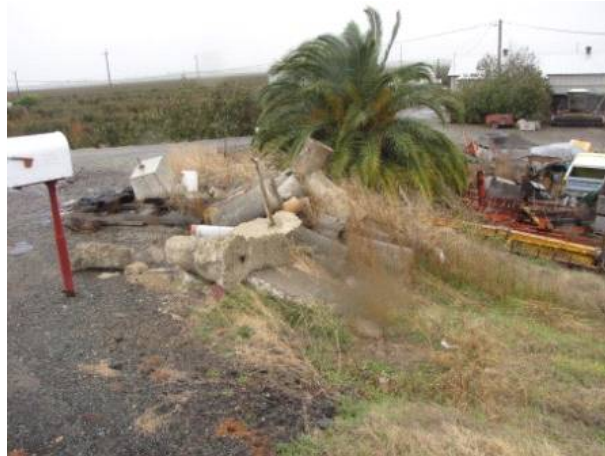
Levee Mile Report Line	16
Start Levee Mile	2.11
End Levee Mile	2.11
Location	Land Side
Category	Earthen Levee
Item	Encroachments

Looking northeast at concrete rubble at landside shoulder and ramp.

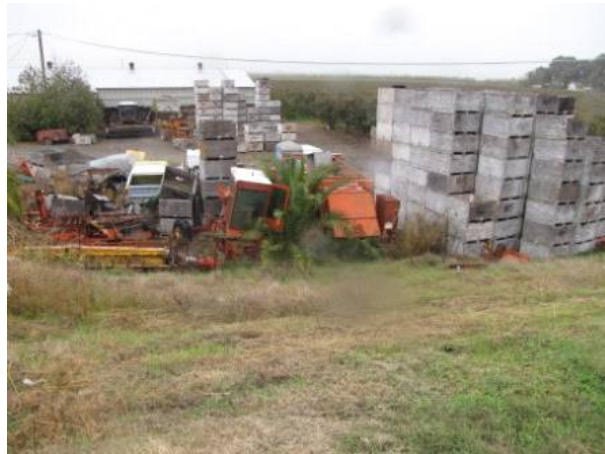
Levee Mile Report Line	16
Start Levee Mile	2.11
End Levee Mile	2.11
Location	Land Side
Category	Earthen Levee
Item	Encroachments

Looking north at equipment and storage containers at landside toe.

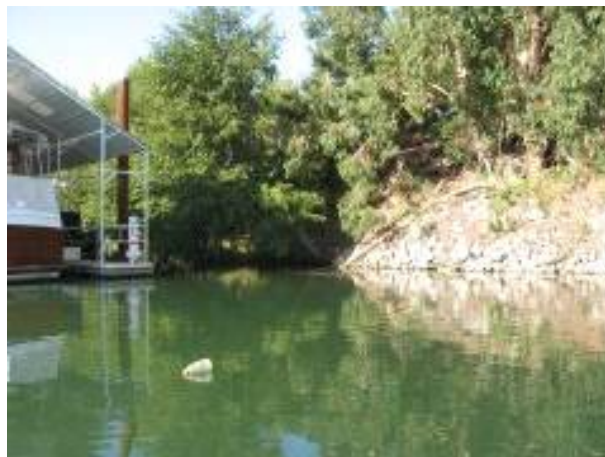
Levee Mile Report Line	17
Start Levee Mile	2.80
End Levee Mile	2.83
Location	Water Side
Category	Supplemental
Item	USACE Erosion Survey

2009: no berm, 1.5:1 slope, tree hazards, clays and silts, 4.66 ft/s [2009 SiteID:STM_23-2_L]

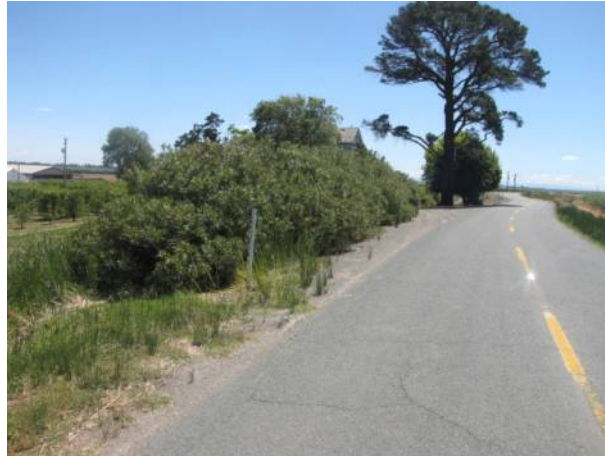
Levee Mile Report Line	18
Start Levee Mile	3.13
End Levee Mile	3.15
Location	Land Side
Category	Earthen Levee
Item	Encroachments

Looking northeast at dense veg. on landside slope.

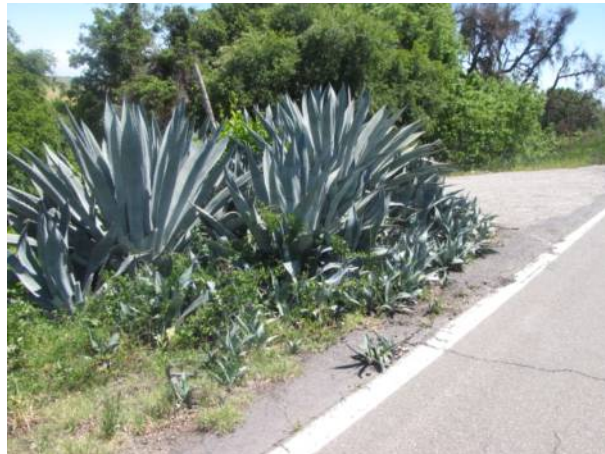
Levee Mile Report Line	25
Start Levee Mile	5.54
End Levee Mile	5.54
Location	Land Side
Category	Earthen Levee
Item	Vegetation

Looking northeast at century plants on landside shoulder and slope.

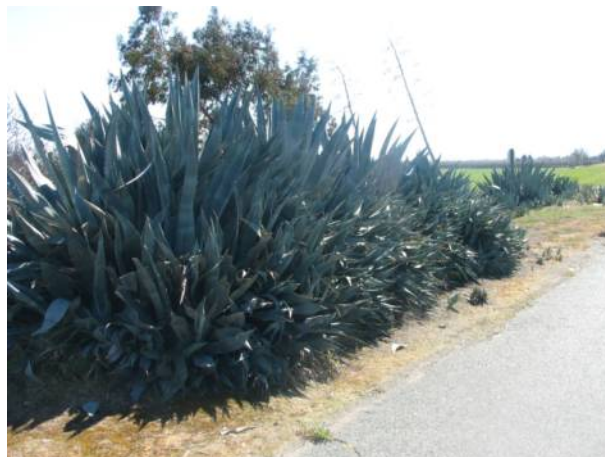
Levee Mile Report Line	26
Start Levee Mile	7.08
End Levee Mile	7.10
Location	Land Side
Category	Earthen Levee
Item	Encroachments

Large Cactus plant on landside shoulder block view of levee slope from LM 7.08 to 7.10

26	7.08	7.10	Earthen Levee	Encroachments	LS	PO	Landscaping Inspector Comments: Remove century plant on landside shoulder and slope. Picture no. 7	38.215490 ° -121.604700 °	38.215355 ° -121.604793 °	23 Y
27	7.81	7.83	Earthen Levee	Encroachments	WS	PO	Landscaping	38.205964 ° -121.609576 °	38.205733 ° -121.609608 °	971 Y
28	7.95	8.00	Earthen Levee	Encroachments	LS	CO	Landscaping	38.203945 ° -121.609932 °	38.203283 ° -121.610025 °	25 Y
29	8.45	8.45	Earthen Levee	Encroachments	LS	PO	Landscaping	38.197194 ° -121.612947 °	38.197194 ° -121.612947 °	17
30	8.95	8.95	Earthen Levee	Trim / Thin Trees	LS	N	Tree stumps.	38.193142 ° -121.620206 °	38.193142 ° -121.620206 °	18

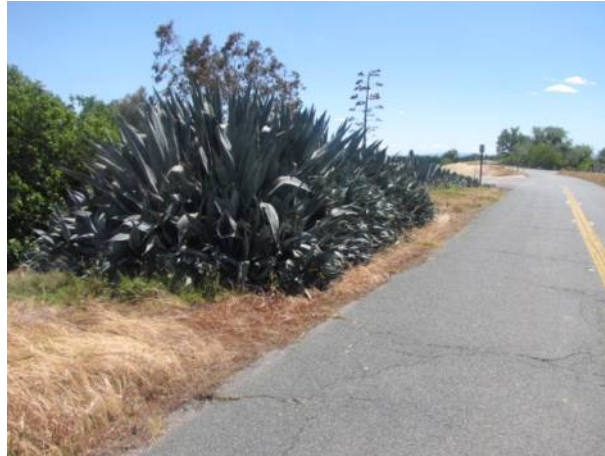
Levee Mile Report Line	26
Start Levee Mile	7.08
End Levee Mile	7.10
Location	Land Side
Category	Earthen Levee
Item	Encroachments

Looking northeast at updated picture (5/2010) century plant on landside shoulder and slope.

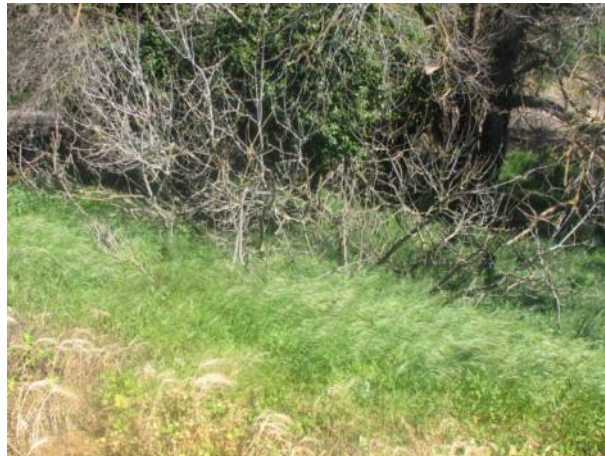
Levee Mile Report Line	27
Start Levee Mile	7.81
End Levee Mile	7.83
Location	Water Side
Category	Earthen Levee
Item	Encroachments

Front view of dense trees at landside toe.

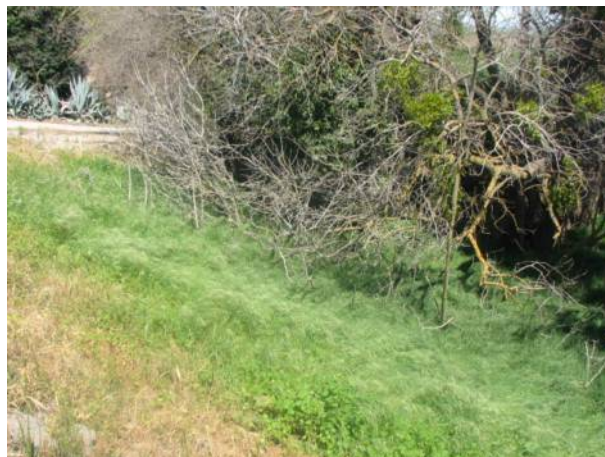
Levee Mile Report Line	27
Start Levee Mile	7.81
End Levee Mile	7.83
Location	Water Side
Category	Earthen Levee
Item	Encroachments

Side view of dense trees at landside toe.

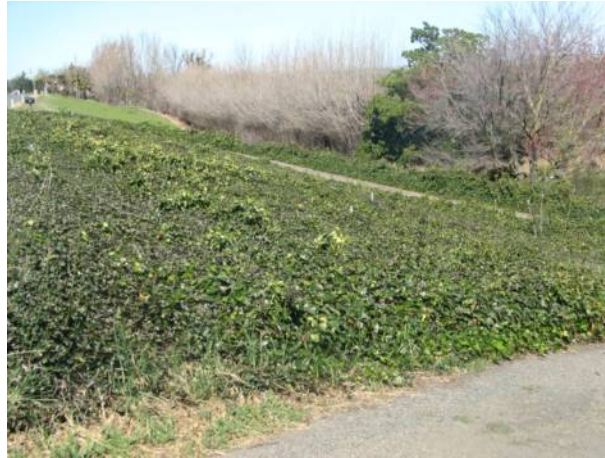
Levee Mile Report Line	28
Start Levee Mile	7.95
End Levee Mile	8.00
Location	Land Side
Category	Earthen Levee
Item	Encroachments

Landscaping (Ivy) on landside slope blocking view of levee from LM 7.95 to 8.00

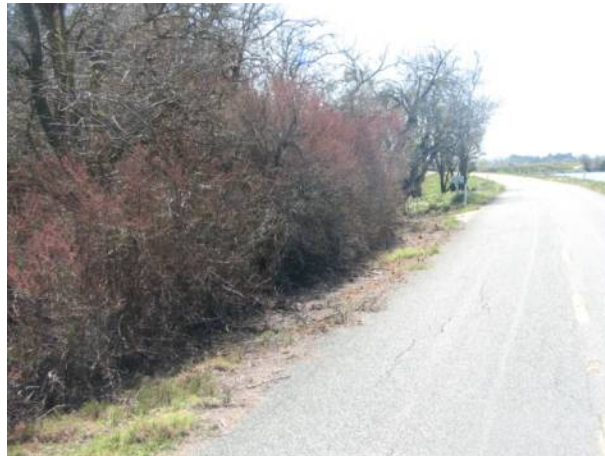
Levee Mile Report Line	31
Start Levee Mile	10.20
End Levee Mile	10.22
Location	Land Side
Category	Earthen Levee
Item	Trim / Thin Trees

Trees to be trimmed on landside shoulder from LM 10.20 to 10.22

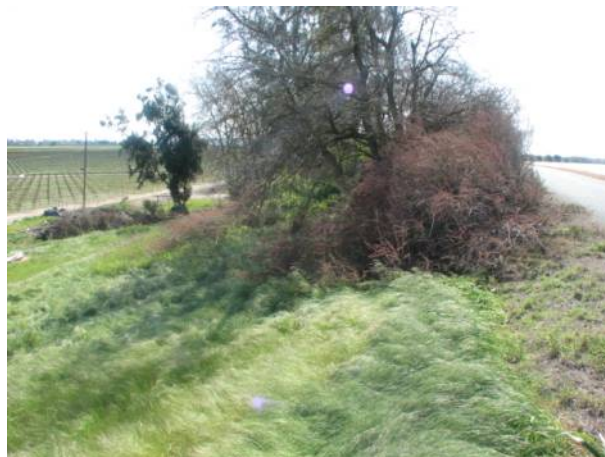
Levee Mile Report Line	31
Start Levee Mile	10.20
End Levee Mile	10.22
Location	Land Side
Category	Earthen Levee
Item	Trim / Thin Trees

Side view of trees on landside shoulder.

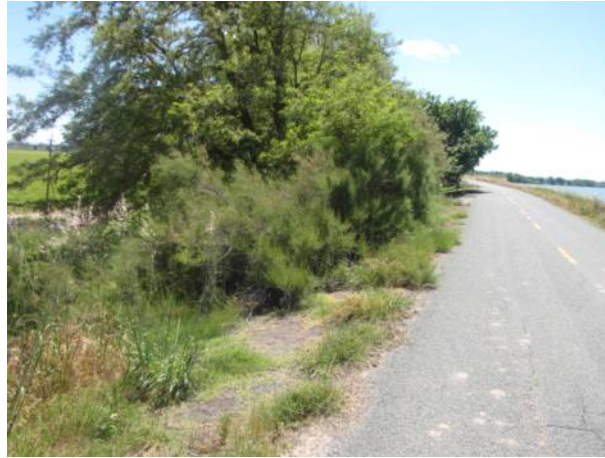
Levee Mile Report Line	31
Start Levee Mile	10.20
End Levee Mile	10.22
Location	Land Side
Category	Earthen Levee
Item	Trim / Thin Trees
Looking north at updated picture (5/10) of dense trees on landside slope.	
richard_s_20100513_081.jpg

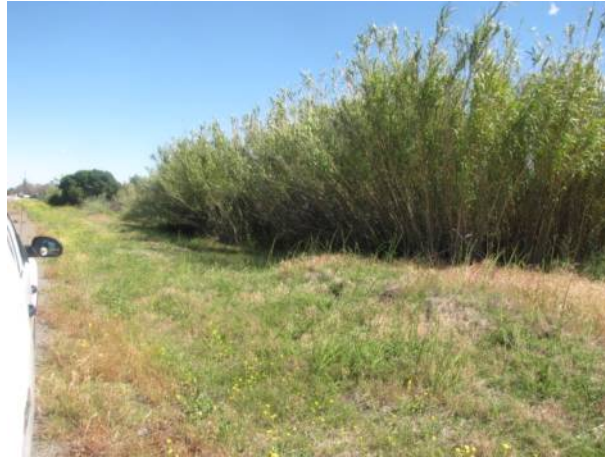
Levee Mile Report Line	5
Start Levee Mile	0.31
End Levee Mile	0.33
Location	Water Side
Category	Earthen Levee
Item	Vegetation

Looking northeast at bamboo on waterside slope.

5	0.31	0.33	Earthen Levee	Vegetation	WS	U	Remove the wild growth other than native grasses from the levee slopes. Inspector Comments: Picture no. 9	38.174281 ° -121.648698 °	38.174209 ° -121.648352 °	5 Y
6	1.93	1.98	Earthen Levee	Encroachments	WS	CO	Landscaping	38.166525 ° -121.622201 °	38.166176 ° -121.621332 °	70
7	2.50	2.50	Earthen Levee	Trim / Thin Trees	LS	M	Trim trees to at least five feet above ground level.	38.164369 ° -121.612548 °	38.164369 ° -121.612548 °	6
8	2.75	2.80	Earthen Levee	Trim / Thin Trees	LS	M	Trim trees to at least five feet above ground level.	38.164430 ° -121.609077 °	38.164725 ° -121.607141 °	951
9	3.29	3.29	Earthen Levee	Trim / Thin Trees	LS	M	Trim trees to at least five feet above ground level.	38.167808 ° -121.599557 °	38.167808 ° -121.599557 °	7
10	3.83	3.92	Earthen Levee	Trim / Thin Trees	LS	M	Trim trees to at least five feet above ground level.	38.173977 ° -121.593725 °	38.175118 ° -121.592925 °	8

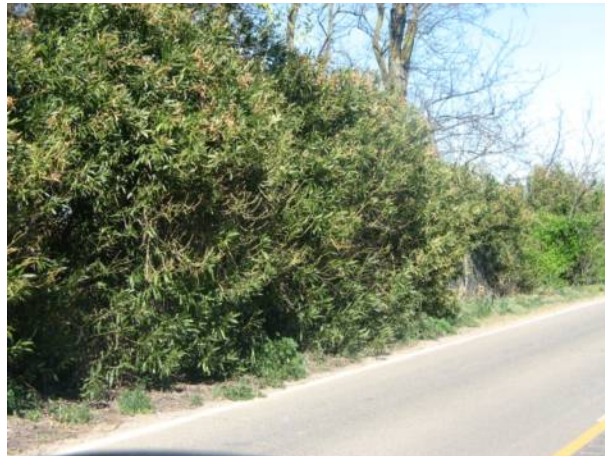
Levee Mile Report Line	18
Start Levee Mile	5.94
End Levee Mile	6.00
Location	Land Side
Category	Earthen Levee
Item	Encroachments

Oleander on landside shoulder blocking view of levee slope from LM 5.94 to 6.00

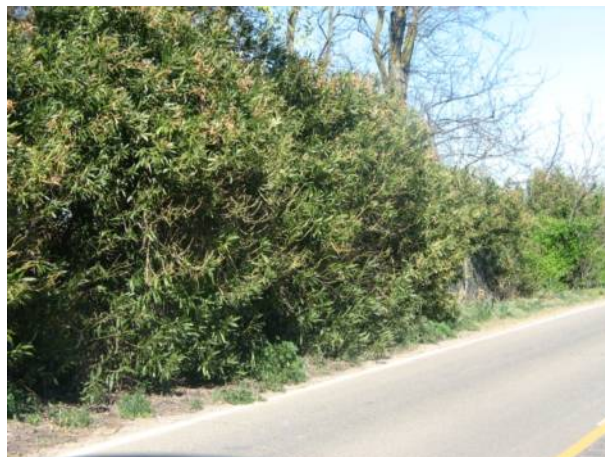
Levee Mile Report Line	18
Start Levee Mile	5.94
End Levee Mile	6.00
Location	Land Side
Category	Earthen Levee
Item	Encroachments

Oleander on landside shoulder blocking view of levee slope from LM 5.94 to 6.00

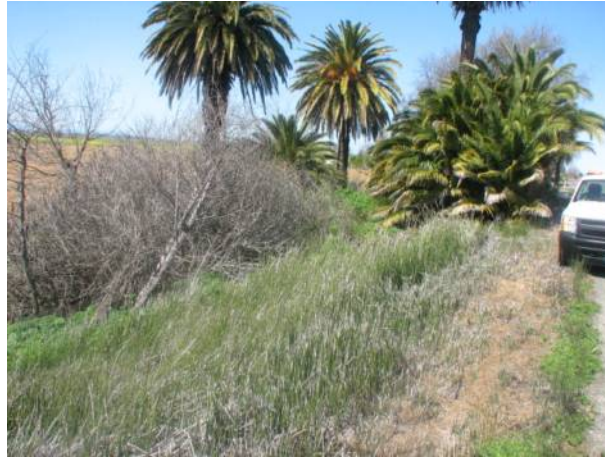
Dense trees at landside toe and shoulder

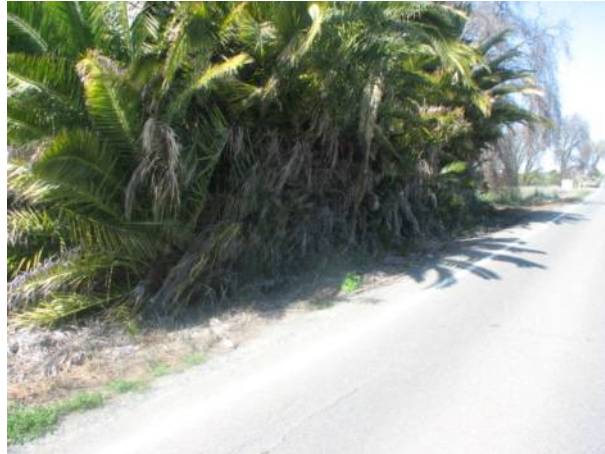
Levee Mile Report Line	20
Start Levee Mile	7.02
End Levee Mile	7.04
Location	Land Side
Category	Earthen Levee
Item	Trim / Thin Trees

Front view of palm trees on landside shoulder

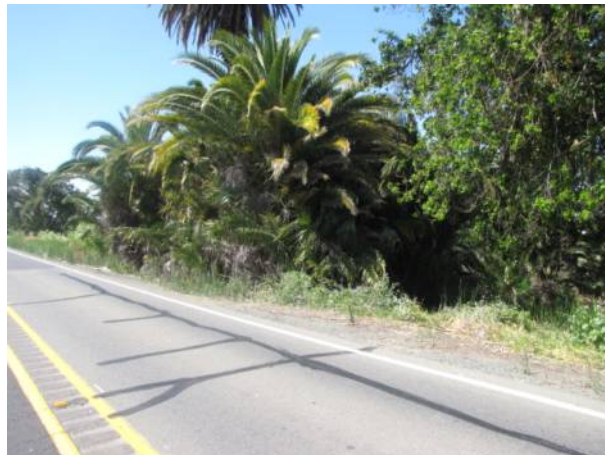
Levee Mile Report Line	20
Start Levee Mile	7.02
End Levee Mile	7.04
Location	Land Side
Category	Earthen Levee
Item	Trim / Thin Trees

Looking southwest at updated dense veg on landside slope.

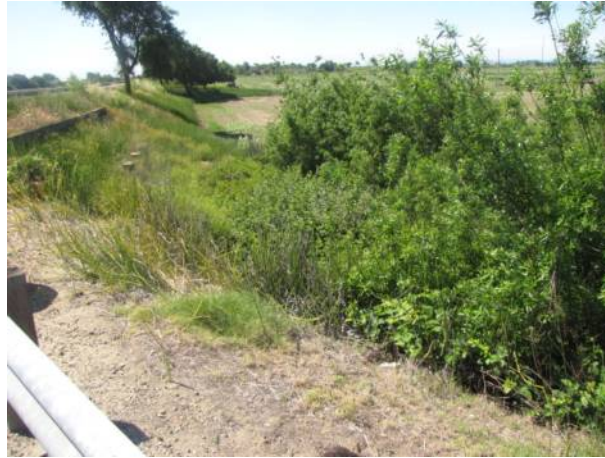
Looking southwest at dense veg. on landside toe.

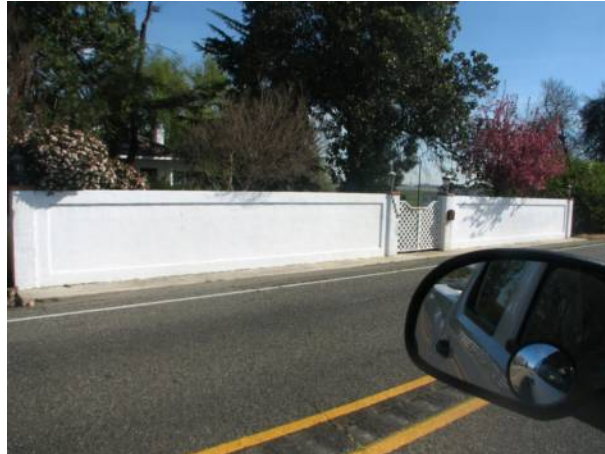
Levee Mile Report Line	27
Start Levee Mile	10.13
End Levee Mile	10.13
Location	Land Side
Category	Earthen Levee
Item	Encroachments

Block/Concrete fence on landside shoulder at LM 10.13

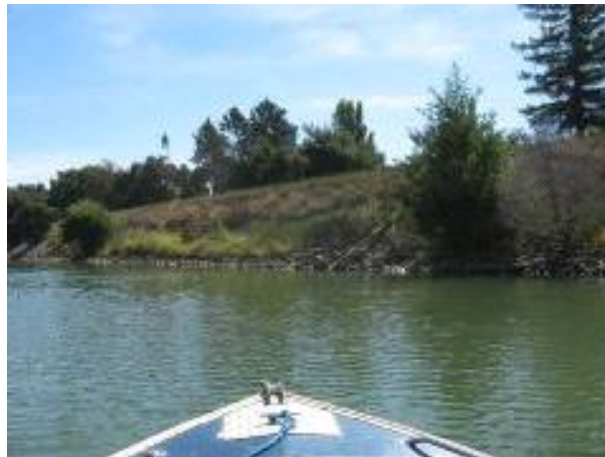
Levee Mile Report Line	51
Start Levee Mile	16.80
End Levee Mile	16.88
Location	Water Side
Category	Supplemental
Item	USACE Erosion Survey

2009: no berm, 1.5:1 slope, no stability issues, sands and silts, 5.23 ft/s [2009 SiteID:SAC_31-6_R]
